# Manhole Inspection Report

Date:	<b>03/22/2018</b>	Weather:		Coding:	<b>RZMACP</b>
MH#:	<b>M-108-030</b>	Owner:	<b>NA</b>	Len. Surveyed:	<b>8.6</b>
P.O.#:		Surveyor:	<b>John Kuglmaier</b>	Rim to Invert:	<b>8.8</b>
Customer:		Cert. #:	<b>U-1215-07002349</b>	Wall Material:	<b>Concrete (reinforced)</b>

Street:	<b>East of Mississippi St. 115' South of</b>	Project:	<b>Hobart, IN</b>
City:	<b>Hobart, IN</b>	GPS Northing:	<b>0.0</b>
Location:		GPS Easting:	<b>0.0</b>
Drain Area:	<b>Southwest</b>	GPS Accuracy:	<b>Nearest Meter</b>
Cover Shape:	<b>Circular</b>	Evidence of Surcharge:	<b>Yes</b>
Cover Size:	<b>22.5</b>	Potential for Runoff:	<b>None</b>
Comments:

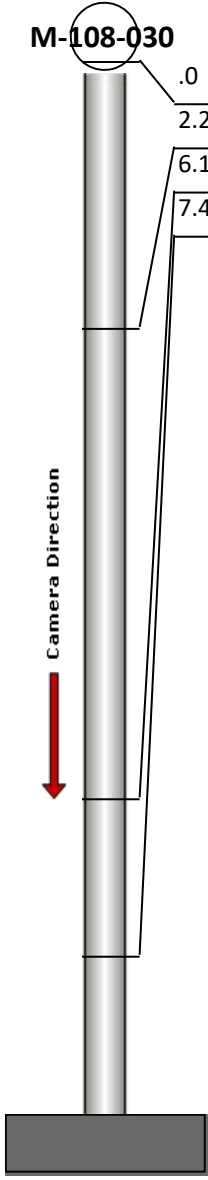
.0	MGP	General Photo	10	NA
	2.2	MGP	General Photo	28	NA
	6.1	DAZ	Deposits Attached Other	50	M 2
	7.4	MGO	General Observation	64	NA

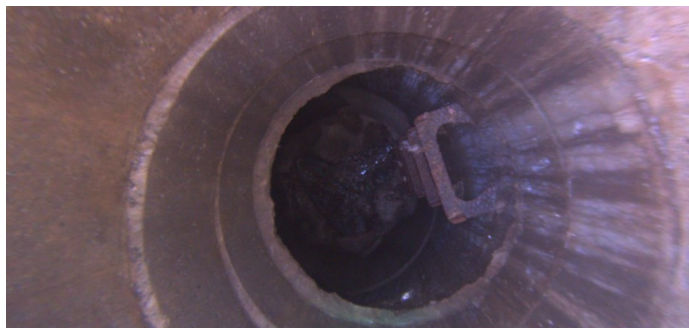
Code: **MGP**  
Description: **General Photo**

Distance (ft): **.0**  
Structural Grade: **0**  
O&M Grade: **0**  
Clock Start/From:  
Clock To:  
1st Value:  
2nd Value:  
Value Percent:  
Step: **NO**  
Remarks:

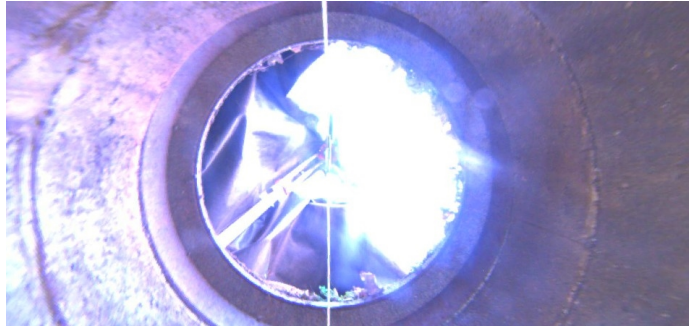
Code: **MGP**  
Description: **General Photo**

Distance (ft): **2.2**  
Structural Grade: **0**  
O&M Grade: **0**  
Clock Start/From:  
Clock To:  
1st Value:  
2nd Value:  
Value Percent:  
Step: **NO**  
Remarks:

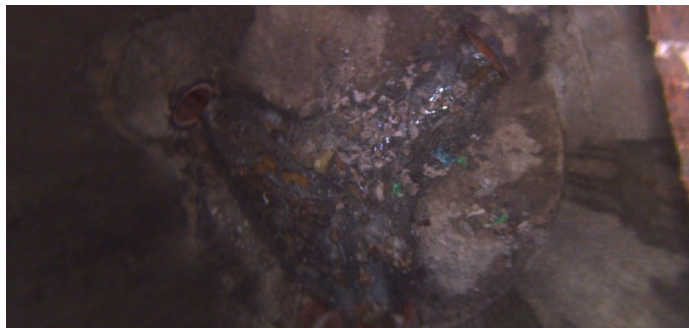
Code: **DAZ**  
Description: **Deposits Attached Other**

Distance (ft): **6.1**  
Structural Grade: **0**  
O&M Grade: **2**  
Clock Start/From: **12**  
Clock To: **12**  
1st Value:  
2nd Value:  
Value Percent: **5.000**  
Step: **NO**  
Remarks: **Mixed materials**

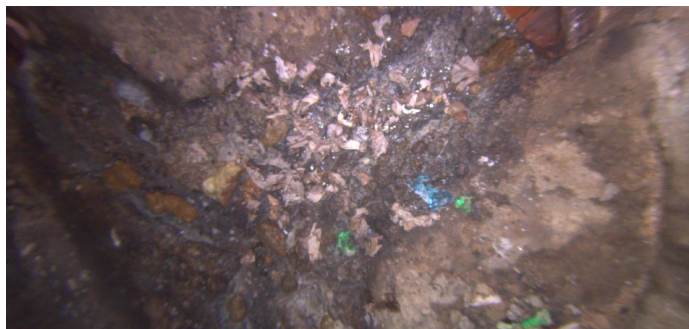
Code: **MGO**  
Description: **General Observation**

Distance (ft): **7.4**  
Structural Grade: **0**  
O&M Grade: **0**  
Clock Start/From:  
Clock To:  
1st Value:  
2nd Value:  
Value Percent:  
Step: **NO**  
Remarks: **Ins. Comp.**
