Manhole Inspection Report

Date:	04/17/2018	Weather:		Coding:	RZMACP
MH#:	M-203-046	Owner:	NA	Len. Surveyed:	3.0
P.O.#:		Surveyor:	Jen Costello	Rim to Invert:	3.7
Customer:		Cert. #:	U-907-5518	Wall Material:	Concrete (reinforced)

Street:	Evergreen St. 141' North of 39th Ave	Project:	Hobart, IN
City:	Hobart, IN	GPS Northing:	0.0
Location:		GPS Easting:	0.0
Drain Area:	Northwest	GPS Accuracy:	Nearest Meter
Cover Shape:	Circular	Evidence of Surcharge:	No
Cover Size:	23.0	Potential for Runoff:	None
Comments:

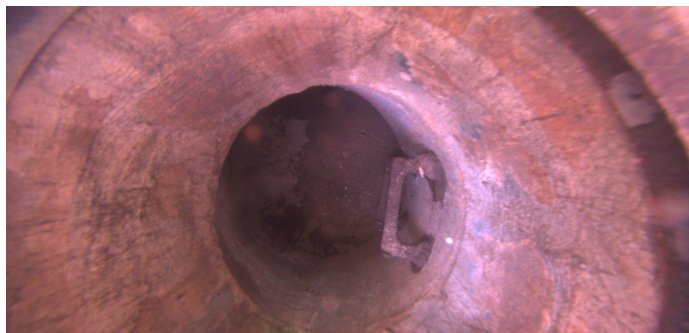
Code: **MGO**
Description: **General Observation**

Distance (ft): **.0**
Structural Grade: **0**
O&M Grade: **0**
Clock Start/From:
Clock To:
1st Value:
2nd Value:
Value Percent:
Step: **NO**
Remarks: **ACCESS MH**

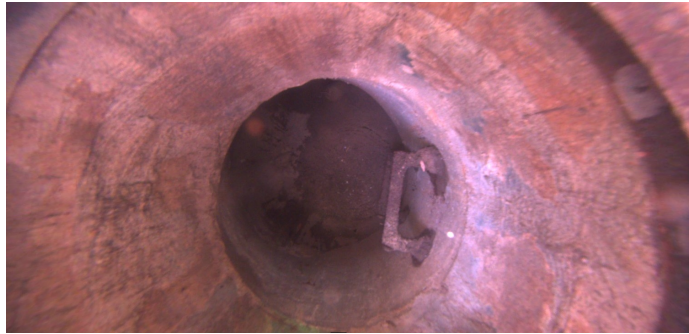
Code: **CM**
Description: **Crack Multiple**

Distance (ft): **.0**
Structural Grade: **3**
O&M Grade: **0**
Clock Start/From: **12**
Clock To: **12**
1st Value:
2nd Value:
Value Percent:
Step: **NO**
Remarks:

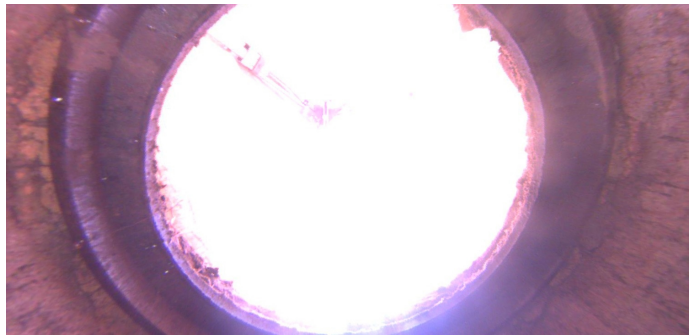
Code: **MGO**
Description: **General Observation**

Distance (ft): **1.0**
Structural Grade: **0**
O&M Grade: **0**
Clock Start/From:
Clock To:
1st Value:
2nd Value:
Value Percent:
Step: **NO**
Remarks: **UNDERSIDE OF FRAME**

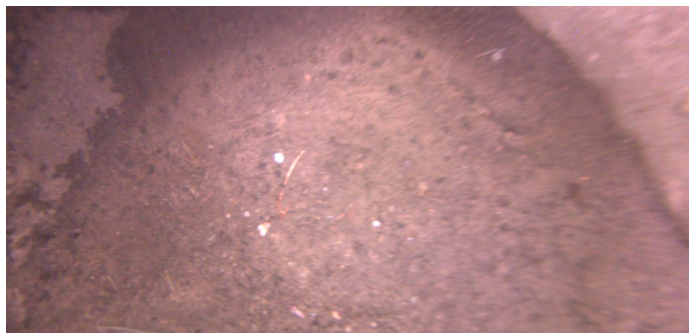
Code: **DSF**
Description: **Deposits Settled Fine**

Distance (ft): **2.9**
Structural Grade: **0**
O&M Grade: **2**
Clock Start/From: **12**
Clock To: **12**
1st Value:
2nd Value:
Value Percent: **10.000**
Step: **NO**
Remarks:

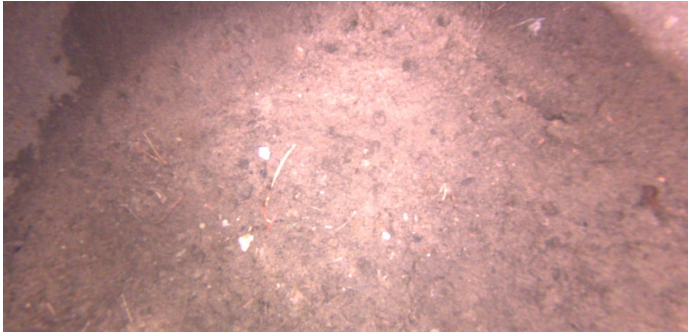
Code:	MGO
Description:	General Observation
Distance (ft):	3.0
Structural Grade:	0
O&M Grade:	0
Clock Start/From:	
Clock To:	
1st Value:	
2nd Value:	
Value Percent:	
Step:	NO
Remarks:	END SURVEY
