Manhole Inspection Report

Date:	05/15/2018	Weather:		Coding:	RZMACP
MH#:	M-404-015	Owner:	NA	Len. Surveyed:	9.0
P.O.#:		Surveyor:	Jen Costello	Rim to Invert:	10.0
Customer:		Cert. #:	U-907-5518	Wall Material:	Concrete (reinforced)

Street:	Wabash St. 52' North of Ridge Rd.	Project:	Hobart, IN
City:	Hobart, IN	GPS Northing:	41.5412941
Location:		GPS Easting:	-87.27960205
Drain Area:	Northwest	GPS Accuracy:	Nearest Meter
Cover Shape:	Circular	Evidence of Surcharge:	No
Cover Size:	22.5	Potential for Runoff:	None
Comments:

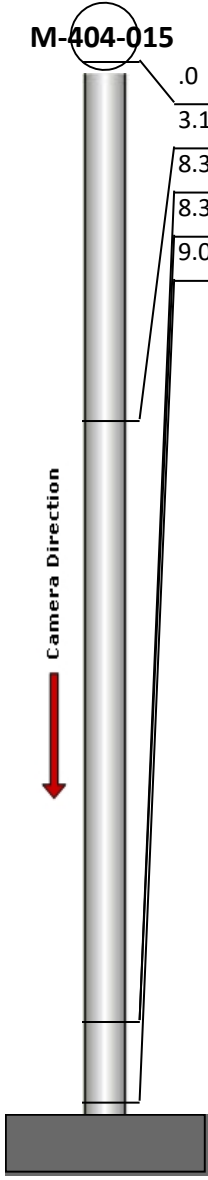
M-404-015				
	.0	MGO	General Observation	10	NA
	3.1	MGO	General Observation	30	NA
	8.3	IW	Infil Weeper	54	M 2
	8.3	DSF	Deposits Settled Fine	66	M 2
	9.0	MGO	General Observation	79	NA

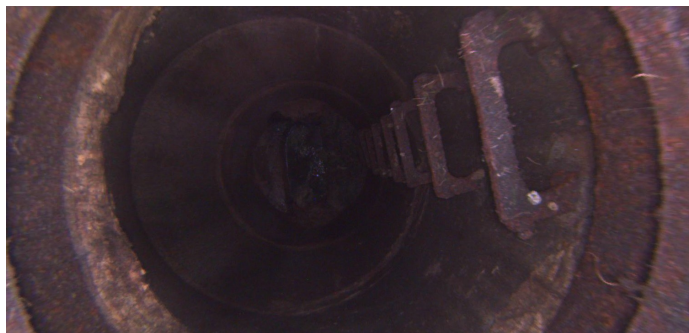
Code: **MGO**
Description: **General Observation**

Distance (ft): **.0**
Structural Grade: **0**
O&M Grade: **0**
Clock Start/From:
Clock To:
1st Value:
2nd Value:
Value Percent:
Step: **NO**
Remarks: **ACCESS MH**

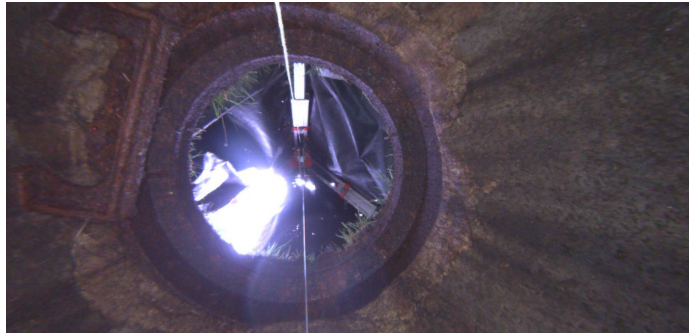
Code: **MGO**
Description: **General Observation**

Distance (ft): **3.1**
Structural Grade: **0**
O&M Grade: **0**
Clock Start/From:
Clock To:
1st Value:
2nd Value:
Value Percent:
Step: **NO**
Remarks: **UNDERSIDE OF FRAME**

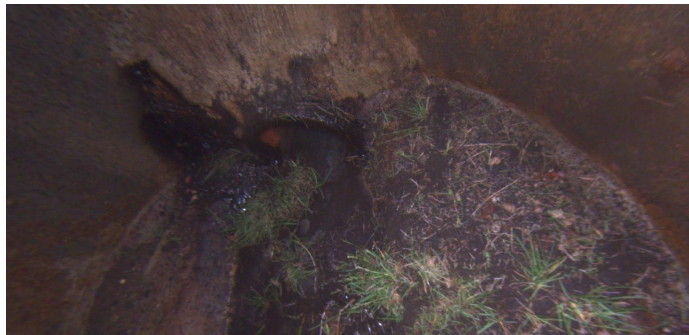
Code: **IW**
Description: **Infil Weeper**

Distance (ft): **8.3**
Structural Grade: **0**
O&M Grade: **2**
Clock Start/From: **11**
Clock To:
1st Value:
2nd Value:
Value Percent:
Step: **NO**
Remarks:

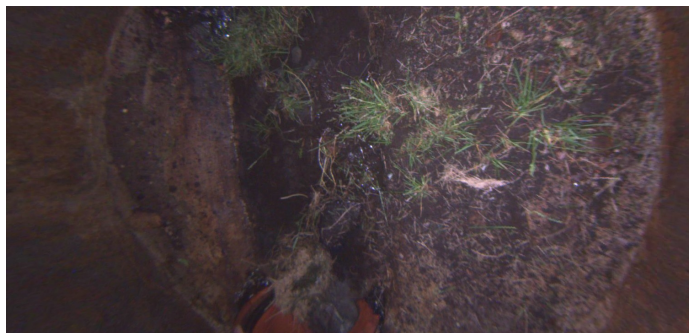
Code: **DSF**
Description: **Deposits Settled Fine**

Distance (ft): **8.3**
Structural Grade: **0**
O&M Grade: **2**
Clock Start/From: **12**
Clock To: **6**
1st Value:
2nd Value:
Value Percent: **5.000**
Step: **NO**
Remarks:

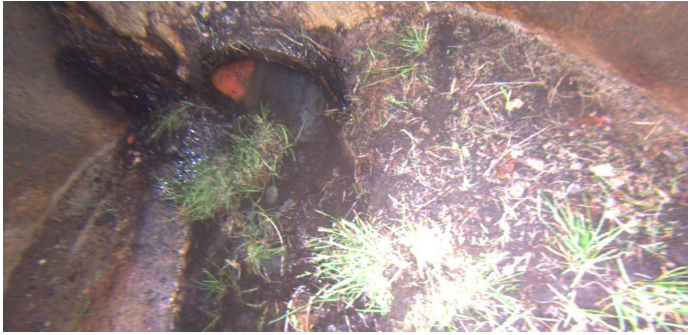
Code:	MGO
Description:	General Observation
Distance (ft):	9.0
Structural Grade:	0
O&M Grade:	0
Clock Start/From:	
Clock To:	
1st Value:	
2nd Value:	
Value Percent:	
Step:	NO
Remarks:	END SURVEY
