Manhole Inspection Report

Street:	Wisconsin St. 166' North of 38th Ave	Project:	Hobart, IN
City:	Hobart, IN	GPS Northing:	0.0
Location:		GPS Easting:	0.0
Drain Area:	Northwest	GPS Accuracy:	Nearest Meter
Cover Shape:	Circular	Evidence of Surcharge:	Yes
Cover Size:	23.0	Potential for Runoff:	None
Comments:

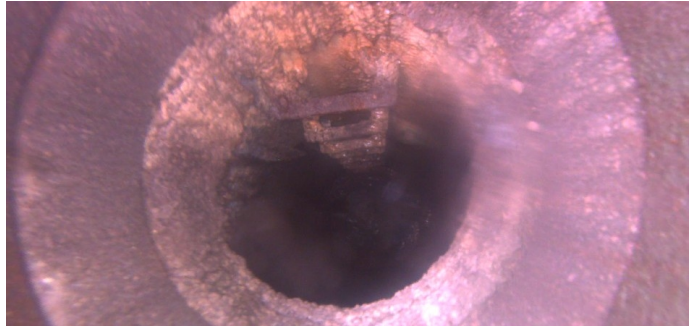
Code:	MGP
Description:	General Photo

Distance (ft):	.0
Structural Grade:	0
O&M Grade:	0
Clock Start/From:	
Clock To:	
1st Value:	
2nd Value:	
Value Percent:	
Step:	NO
Remarks:

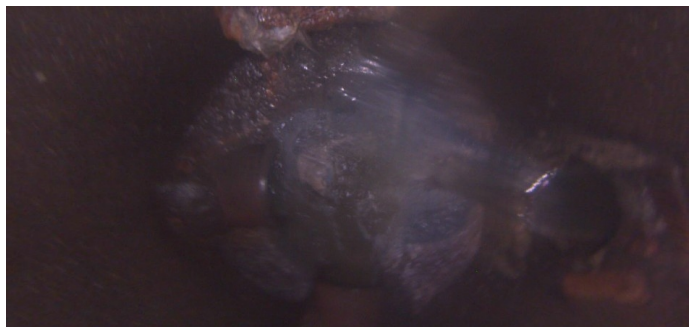
Code: **MGP**
Description: **General Photo**

Distance (ft): **2.7**
Structural Grade: **0**
O&M Grade: **0**
Clock Start/From:
Clock To:
1st Value:
2nd Value:
Value Percent:
Step: **NO**
Remarks:

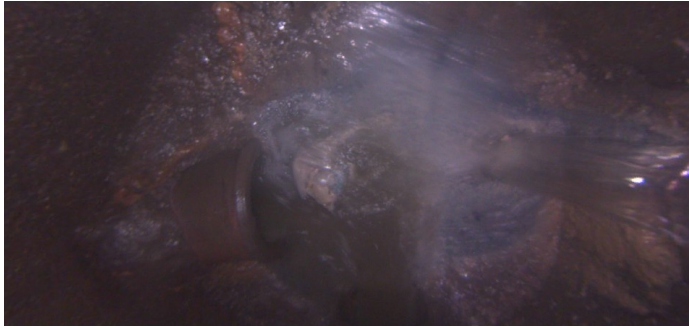
Code: **DAZ**
Description: **Deposits Attached Other**

Distance (ft): **7.2**
Structural Grade: **0**
O&M Grade: **2**
Clock Start/From: **12**
Clock To: **12**
1st Value:
2nd Value:
Value Percent: **10.000**
Step: **NO**
Remarks: **Mixed materials**
