Manhole Inspection Report

Date:	04/08/2018	Weather:		Coding:	RZMACP
MH#:	M-603-031	Owner:	NA	Len. Surveyed:	7.1
P.O.#:		Surveyor:	John Kuglmaier	Rim to Invert:	8.4
Customer:		Cert. #:	U-1215-07002349	Wall Material:	Concrete (reinforced)

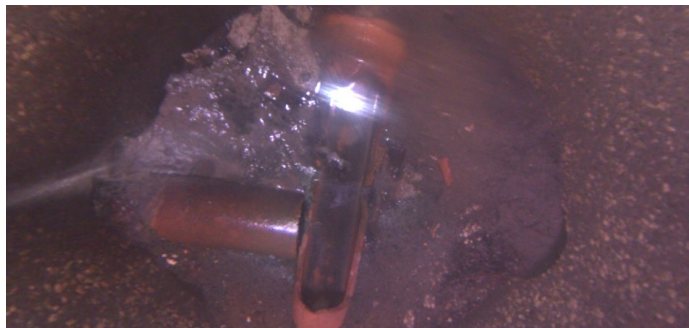
Code: **DAZ**
Description: **Deposits Attached Other**

Distance (ft): **5.8**
Structural Grade: **0**
O&M Grade: **2**
Clock Start/From: **12**
Clock To: **12**
1st Value:
2nd Value:
Value Percent: **10.000**
Step: **NO**
Remarks: **Mixed materials**

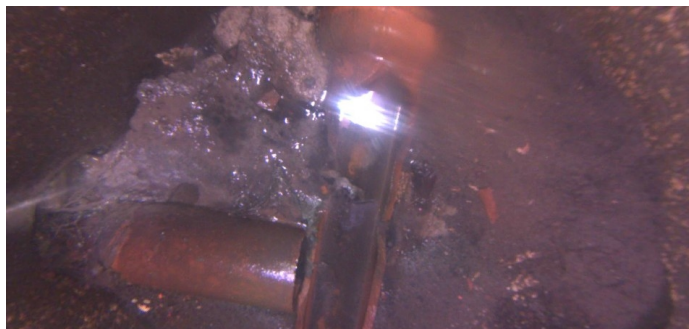
Code: **MGO**
Description: **General Observation**

Distance (ft): **6.3**
Structural Grade: **0**
O&M Grade: **0**
Clock Start/From:
Clock To:
1st Value:
2nd Value:
Value Percent:
Step: **NO**
Remarks: **Ins. Comp.**

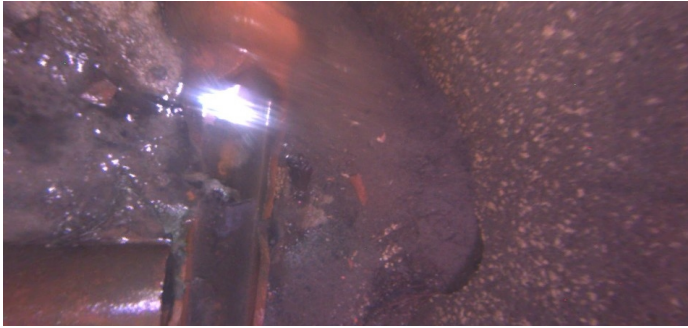
Code:	HSV
Description:	Hole Soil Visible
Distance (ft):	6.3
Structural Grade:	5
O&M Grade:	0
Clock Start/From:	4
Clock To:	
1st Value:	
2nd Value:	
Value Percent:	
Step:	NO
Remarks:
