Manhole Inspection Report

Date:	04/29/2018	Weather:		Coding:	RZMACP
MH#:	M-604-121	Owner:	NA	Len. Surveyed:	6.2
P.O.#:		Surveyor:	Jen Costello	Rim to Invert:	6.4
Customer:		Cert. #:	U-907-5518	Wall Material:	Brick

Street:	Lake Park Ave. and Old Ridge Road.	Project:	Hobart, IN
City:	Hobart, IN	GPS Northing:	2904432.09
Location:		GPS Easting:	2904432.09
Drain Area:	North	GPS Accuracy:	Sub-Meter
Cover Shape:	Circular	Evidence of Surcharge:	No
Cover Size:	22.5	Potential for Runoff:	None
Comments:

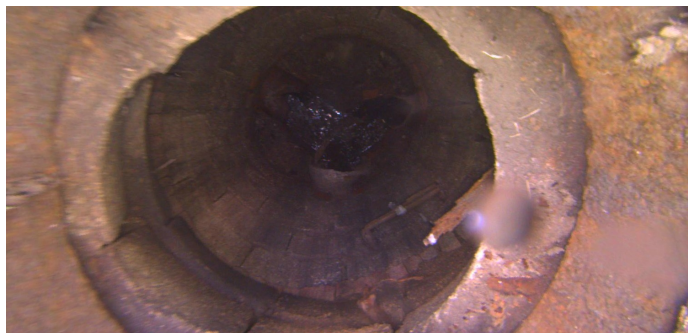
Code: **MGO**
Description: **General Observation**

Distance (ft): **.0**
Structural Grade: **0**
O&M Grade: **0**
Clock Start/From:
Clock To:
1st Value:
2nd Value:
Value Percent:
Step: **NO**
Remarks: **ACCESS MH**

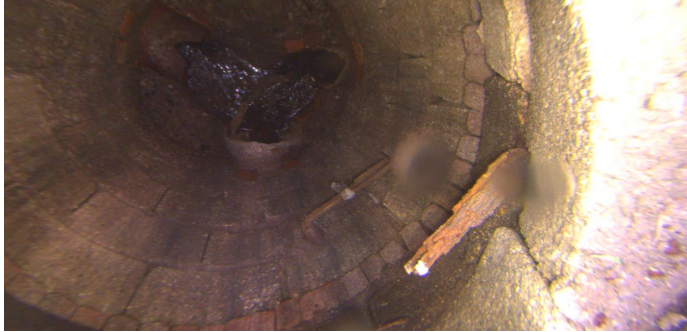
Code: **MGO**
Description: **General Observation**

Distance (ft): **1.1**
Structural Grade: **0**
O&M Grade: **0**
Clock Start/From:
Clock To:
1st Value:
2nd Value:
Value Percent:
Step: **NO**
Remarks: **BROKEN STEP**

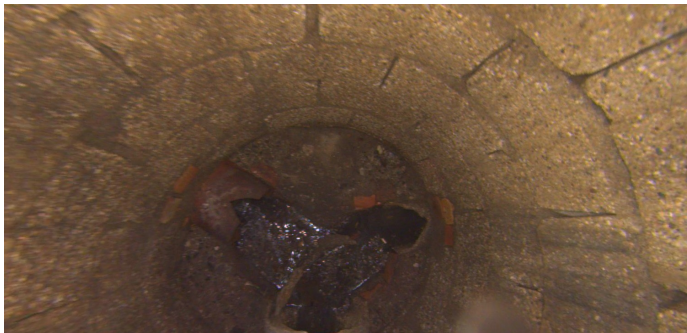
Code: **SAV**
Description: **Surface Aggregate Visible**

Distance (ft): **2.3**
Structural Grade: **3**
O&M Grade: **0**
Clock Start/From: **12**
Clock To: **12**
1st Value:
2nd Value:
Value Percent:
Step: **NO**
Remarks:

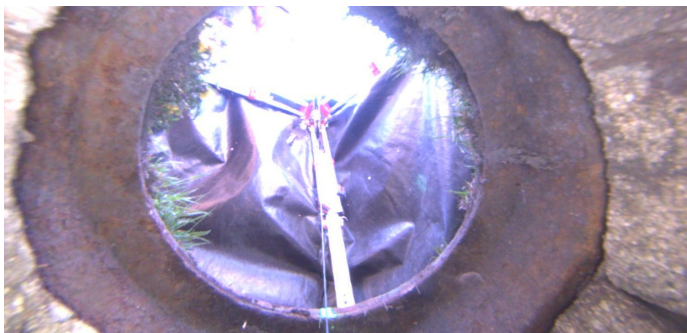
Code: **MGO**
Description: **General Observation**

Distance (ft): **2.3**
Structural Grade: **0**
O&M Grade: **0**
Clock Start/From:
Clock To:
1st Value:
2nd Value:
Value Percent:
Step: **NO**
Remarks: **UNDERSIDE OF FRAME**
