Manhole Inspection Report

Date:	04/17/2018	Weather:		Coding:	RZMACP
MH#:	M-707-024	Owner:	NA	Len. Surveyed:	4.3
P.O.#:		Surveyor:	John Kuglmaier	Rim to Invert:	4.5
Customer:		Cert. #:	U-1215-07002349	Wall Material:	Concrete (reinforced)

Street:	East of Lincoln St. 253' South of 13th	Project:	Hobart, IN
City:	Hobart, IN	GPS Northing:	2906729.53
Location:		GPS Easting:	2906729.53
Drain Area:	Southeast	GPS Accuracy:	Sub-Meter
Cover Shape:	Circular	Evidence of Surcharge:	No
Cover Size:	22.5	Potential for Runoff:	None
Comments:

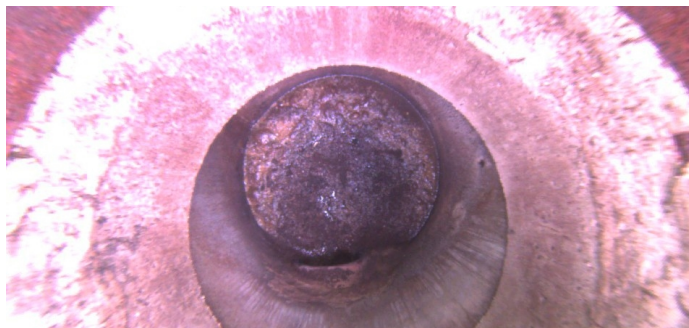
Code: **MGP**
Description: **General Photo**

Distance (ft): **.0**
Structural Grade: **0**
O&M Grade: **0**
Clock Start/From:
Clock To:
1st Value:
2nd Value:
Value Percent:
Step: **NO**
Remarks:

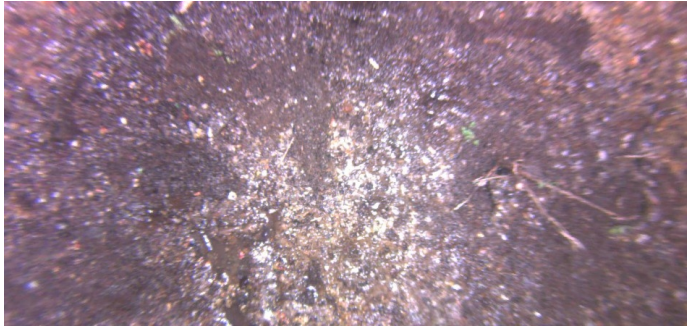
Code:	MGO
Description:	General Observation
Distance (ft):	3.7
Structural Grade:	0
O&M Grade:	0
Clock Start/From:	
Clock To:	
1st Value:	
2nd Value:	
Value Percent:	
Step:	NO
Remarks:	Ins. Comp.
