Profile/Photo Observation Report

Street:	DUNLIN CT & AVOCET CIR	Flow Control:	Not Controlled
City:	Hobart, IN	Year Renewed:	
Location:	Yard	Tape/Media #:	
Purpose:	Maintenance Related	Dia/Height:	8"
Use:	Sanitary	Material:	PVC
Drain Area:	NA	Lining:	
Category:	NA		
Comment:

Location Details:		Direction of Survey:	Upstream
US MH:	M-709-017	DS MH:	M-709-020
		Total Length Surveyed (ft):	91.1

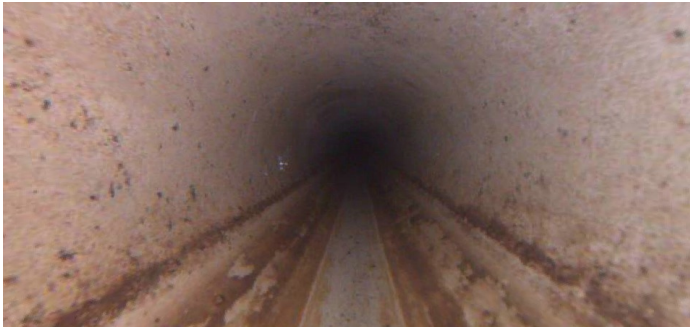
Code: AMH

Description: Manhole

Distance (ft): .0

Remarks: M-709-020

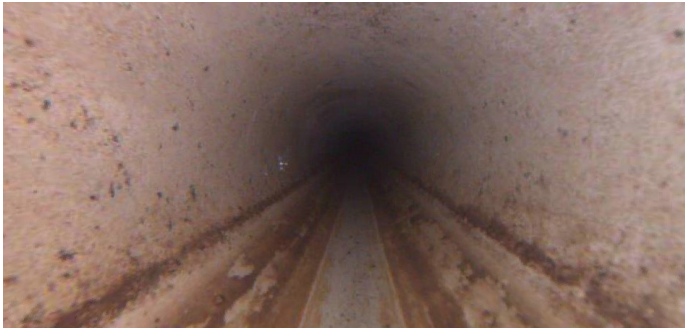
Code:	MWL
Description:	Water Level

Distance (ft):	.0
Structural Grade:	0
O&M Grade:	0
Clock Start/From:	
Clock To:	
1st Value:	
2nd Value:	
Value Percent:	5.000
Continuous Index:	
Within 8" of Joint:	NO
Remarks:

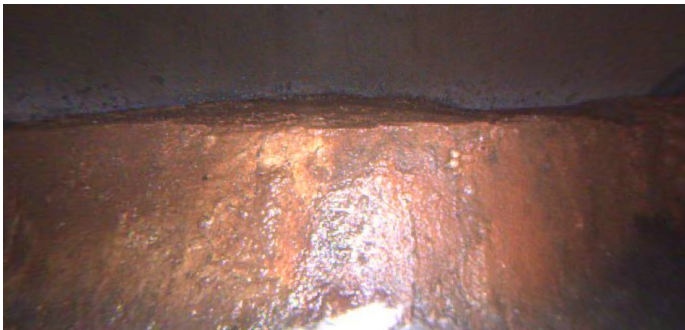
Code:	AMH
Description:	Manhole

Distance (ft):	91.1
Structural Grade:	0
O&M Grade:	0
Clock Start/From:	
Clock To:	
1st Value:	
2nd Value:	
Value Percent:	
Continuous Index:	
Within 8" of Joint:	NO
Remarks:	M-709-017
