Profile/Photo Observation Report

Street:	Avocet	Flow Control:	Not Controlled
City:	Hobart, IN	Year Renewed:	
Location:	Sidewalk	Tape/Media #:	
Purpose:	Maintenance Related	Dia/Height:	8"
Use:	Sanitary	Material:	PVC
Drain Area:	NA	Lining:	Cured in Place
Category:	NA		
Comment:

Location Details:		Direction of Survey:	Downstream
US MH:	M-709-025	DS MH:	M-709-024
		Total Length Surveyed (ft):	79.5

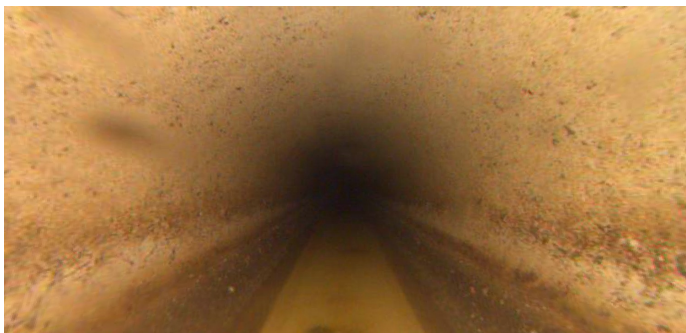
Code: **AMH**
Description: **Manhole**

Distance (ft): **.0**
Structural Grade: **0**
O&M Grade: **0**
Clock Start/From:
Clock To:
1st Value:
2nd Value:
Value Percent:
Continuous Index:
Within 8" of Joint: **NO**
Remarks: **M-709-025**

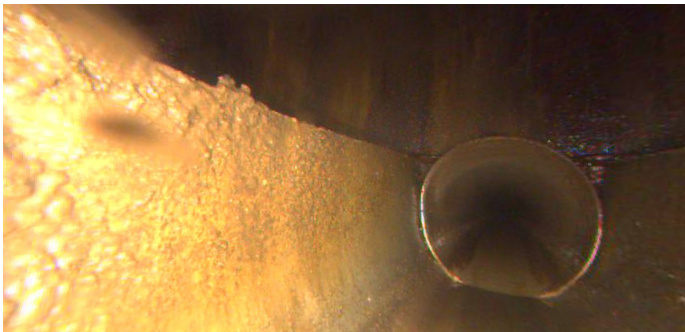
Code:	AMH
Description:	Manhole

Distance (ft):	79.5
Structural Grade:	0
O&M Grade:	0
Clock Start/From:	
Clock To:	
1st Value:	
2nd Value:	
Value Percent:	
Continuous Index:	
Within 8" of Joint:	NO
Remarks:	M-709-024
