Profile/Photo Observation Report

Street:	East Ridge Road	Flow Control:	Not Controlled
City:	Hobart, IN	Year Renewed:	
Location:	Easement/Right of Way	Tape/Media #:	
Purpose:	Routine Assessment	Dia/Height:	12"
Use:	Sanitary Sewage Pipe	Material:	PVC
Drain Area:		Lining:	None
Category:	NA

US MH:	M-903-008	DS MH:	M-903-063	Total Length Surveyed (ft):	182.9
--------	------------------	--------	------------------	-----------------------------	--------------

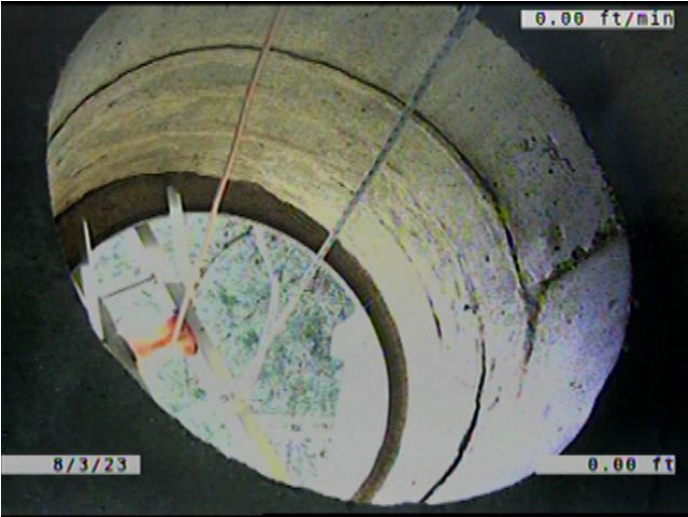
AMH

Manhole

.0

M-903-008

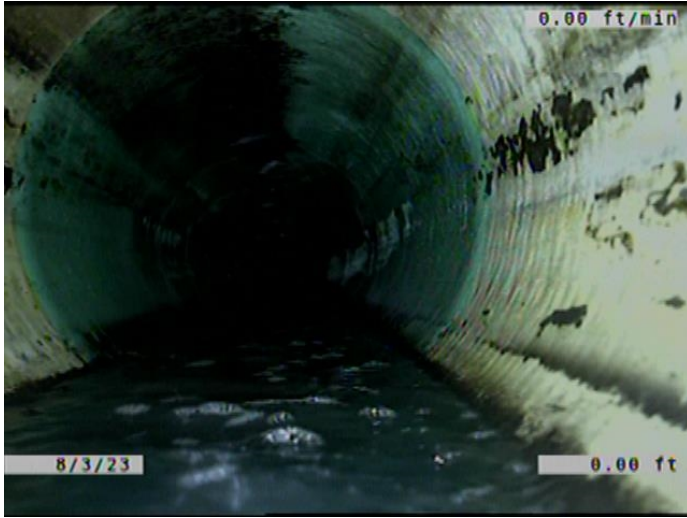
Code:	MWL
Description:	Miscellaneous Water Level
Distance (ft):	.0
Structural Grade:	0
O&M Grade:	0
Clock Start/From:	
Clock To:	
1st Value:	
2nd Value:	
Value Percent:	10.000
Continuous Index:	
Within 8" of Joint:	NO
Remarks:

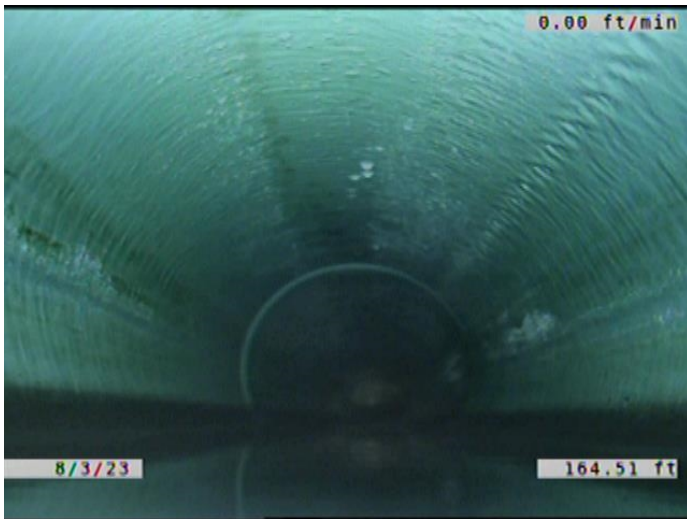
Code:	MWLS
Description:	Miscellaneous Water Level Sag
Distance (ft):	164.5
Structural Grade:	2
O&M Grade:	0
Clock Start/From:	
Clock To:	
1st Value:	
2nd Value:	
Value Percent:	20.000
Continuous Index:	
Within 8" of Joint:	NO
Remarks:

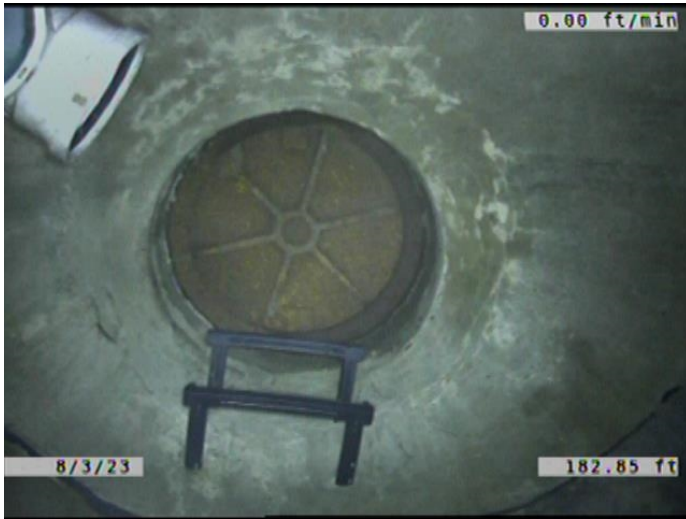
Code:	AMH
Description:	Manhole
Distance (ft):	182.9
Structural Grade:	0
O&M Grade:	0
Clock Start/From:	
Clock To:	
1st Value:	
2nd Value:	
Value Percent:	
Continuous Index:	
Within 8" of Joint:	NO
Remarks:	M-903-063
