## Profile/Photo Observation Report

Street:	<b>RUSH CT &amp; HICKEY PL</b>	Flow Control:	<b>Not Controlled</b>
City:	<b>Hobart, IN</b>	Year Renewed:	
Location:	<b>Other</b>	Tape/Media #:	
Purpose:	<b>Not Known</b>	Dia/Height:	<b>12"</b>
Use:	<b>Sanitary</b>	Material:	<b>VCP</b>
Drain Area:	<b>NA</b>	Lining:	
Category:	<b>NA</b>		
Comment:

Location Details:		Direction of Survey:	<b>Upstream</b>
US MH:	<b>M-904-042</b>	DS MH:	<b>M-904-045</b>
		Total Length Surveyed (ft):	<b>282.2</b>

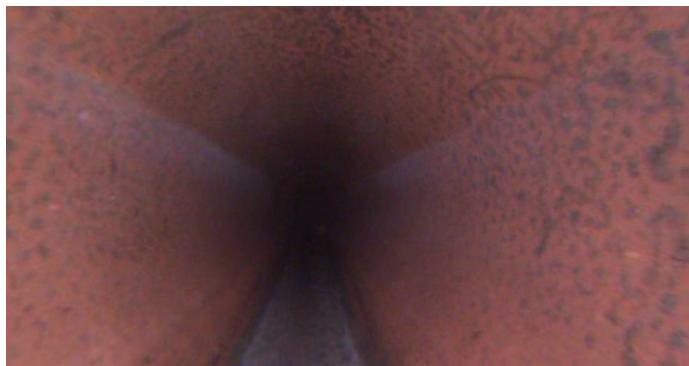
Code: **AMH**  
Description: **Manhole**

Distance (ft): **.0**  
Structural Grade: **0**  
O&M Grade: **0**  
Clock Start/From:  
Clock To:  
1st Value:  
2nd Value:  
Value Percent:  
Continuous Index:  
Within 8" of Joint: **NO**  
Remarks: **M-904-045**

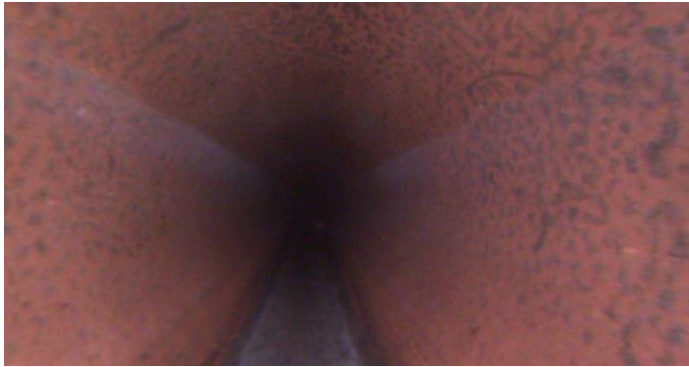
Code:	<b>MWL</b>
Description:	<b>Water Level</b>
Distance (ft):	<b>.0</b>
Structural Grade:	<b>0</b>
O&M Grade:	<b>0</b>
Clock Start/From:	
Clock To:	
1st Value:	
2nd Value:	
Value Percent:	<b>10.000</b>
Continuous Index:	
Within 8" of Joint:	<b>NO</b>
Remarks:

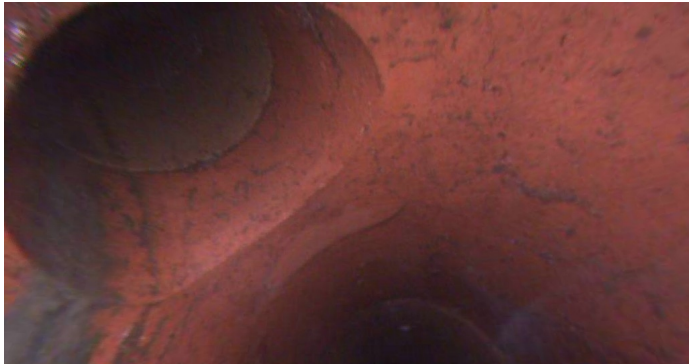
Code:	<b>TF</b>
Description:	<b>Tap Factory</b>
Distance (ft):	<b>16.2</b>
Structural Grade:	<b>0</b>
O&M Grade:	<b>0</b>
Clock Start/From:	<b>10</b>
Clock To:	
1st Value:	<b>4.000</b>
2nd Value:	
Value Percent:	
Continuous Index:	
Within 8" of Joint:	
Remarks:

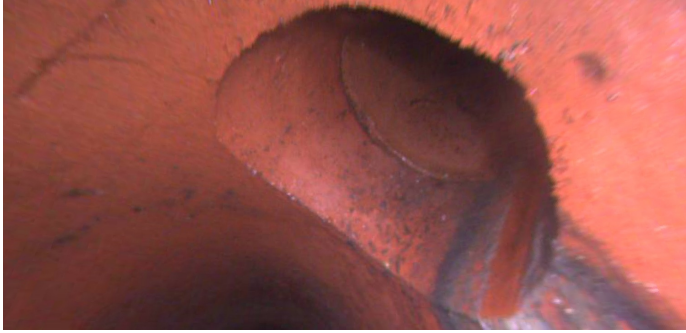
Code: **TFA**  
Description: **Tap Factory Active**

Distance (ft): **28.2**  
Structural Grade: **0**  
O&M Grade: **0**  
Clock Start/From: **1**  
Clock To:  
1st Value: **4.000**  
2nd Value:  
Value Percent:  
Continuous Index:  
Within 8" of Joint:  
Remarks:

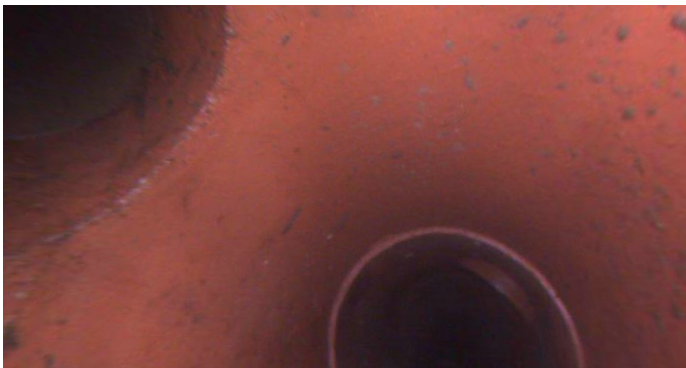
Code: **TF**  
Description: **Tap Factory**

Distance (ft): **80.2**  
Structural Grade: **0**  
O&M Grade: **0**  
Clock Start/From: **10**  
Clock To:  
1st Value: **4.000**  
2nd Value:  
Value Percent:  
Continuous Index:  
Within 8" of Joint:  
Remarks:

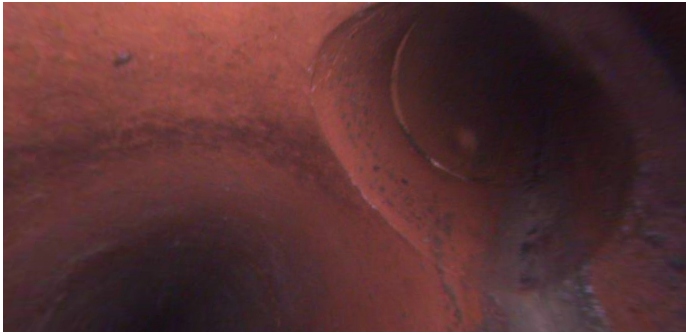
Code: **TFA**  
Description: **Tap Factory Active**

Distance (ft): **82.1**  
Structural Grade: **0**  
O&M Grade: **0**  
Clock Start/From: **2**  
Clock To:  
1st Value: **4.000**  
2nd Value:  
Value Percent:  
Continuous Index:  
Within 8" of Joint:  
Remarks:

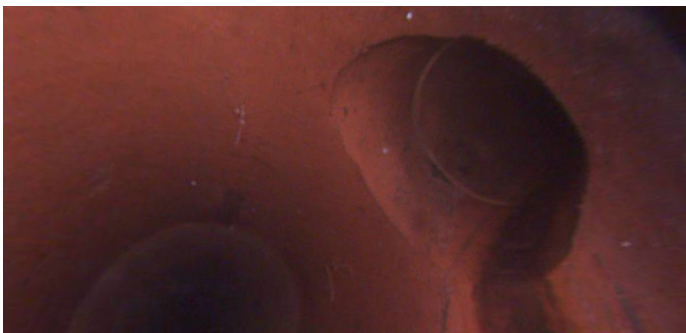
Code: **TFA**  
Description: **Tap Factory Active**

Distance (ft): **164.1**  
Structural Grade: **0**  
O&M Grade: **0**  
Clock Start/From: **2**  
Clock To:  
1st Value: **4.000**  
2nd Value:  
Value Percent:  
Continuous Index:  
Within 8" of Joint:  
Remarks:

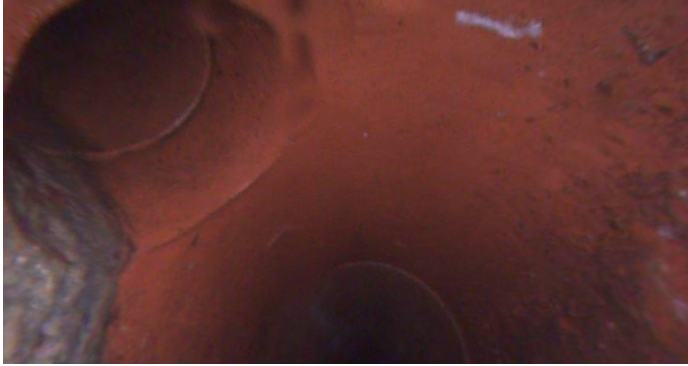
Code: **TF**  
Description: **Tap Factory**

Distance (ft): **216.3**  
Structural Grade: **0**  
O&M Grade: **0**  
Clock Start/From: **10**  
Clock To:  
1st Value: **4.000**  
2nd Value:  
Value Percent:  
Continuous Index:  
Within 8" of Joint:  
Remarks:

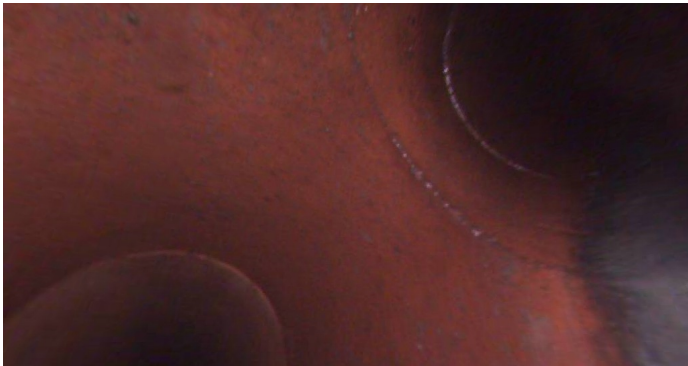
Code: **TF**  
Description: **Tap Factory**

Distance (ft): **238.8**  
Structural Grade: **0**  
O&M Grade: **0**  
Clock Start/From: **2**  
Clock To:  
1st Value: **4.000**  
2nd Value:  
Value Percent:  
Continuous Index:  
Within 8" of Joint:  
Remarks:

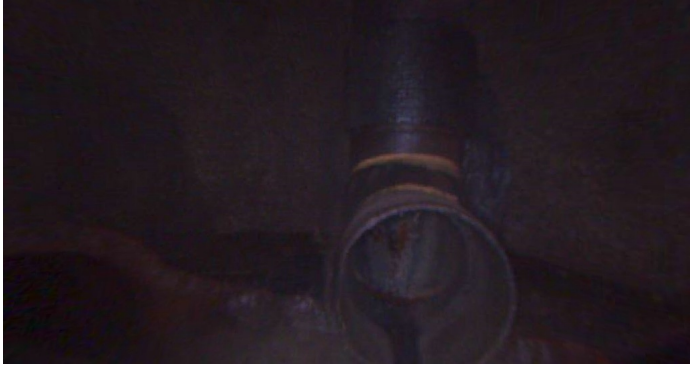
Code:	AMH
Description:	Manhole
Distance (ft):	282.2
Structural Grade:	0
O&M Grade:	0
Clock Start/From:	
Clock To:	
1st Value:	
2nd Value:	
Value Percent:	
Continuous Index:	
Within 8" of Joint:	NO
Remarks:	M-904-042
