Profile/Photo Observation Report

Date:	05/06/2018	Weather:			Coding:	PACP 6.0	
Pipe Length (ft):		Owner:	City of Hoba	ırt	Pre Clean:	No Pre-Cleaning	
P.O.#:	600	Surveyor:	M. Pielacha		PSR:	P-905-013-014	
Customer:	City of Hobart	Clean Date:			Shape:	С	
Street:	Off State Road 130		Flow Control:		Not Controlled		
City:	Hobart, IN		Year Renewed	d:			
Location:	Other		Tape/Media #	‡ :	DEP 600		
Purpose:	Routine Assessment		Dia/Height:		18"		
Use:	Sanitary		Material:		PVC		
Drain Area:			Lining:				
Category:	NA						
Comment:	5-21-2018						
Location Detai	ls:		Direction of S	urvey:	Upstream		
US MH:	M-905-014	DS MH:	M-905-013		Total Length Surveyed (ft):	249.7	
D&M Index:	0.00	O&M Quick:	C	0000	O&M Rating:	0.00	
Structural Index	. 0.00	— Structural Qu	ick:	0000	Structural Rating:	0.00	
Overall Index:	0.00	— Overall Quick	(0000	Overall Rating:	0.00

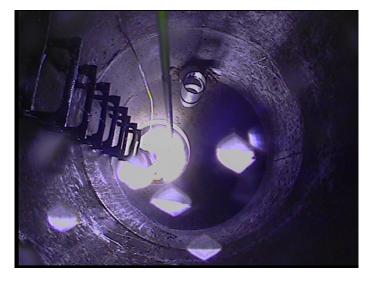
Code:

Description:	Manhole
Distance (ft): Structural Grade:	.0 0
O&M Grade: Clock Start/From:	0
Clock To: 1st Value:	
2nd Value: Value Percent: Continuous Index:	
Within 8" of Joint: Remarks:	NO M-905-013

AMH

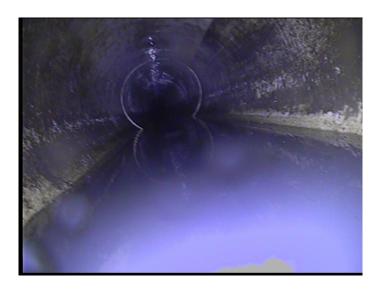
Code: MWL
Description: Water Level

Distance (ft): .0
Structural Grade: 0
O&M Grade: 0
Clock Start/From:

Value Percent: 15.000

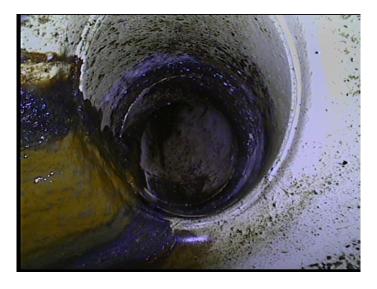
Code: TF
Description: Tap Factory

Distance (ft): 186.1
Structural Grade: 0
O&M Grade: 0
Clock Start/From: 10

1st Value: **4.000**

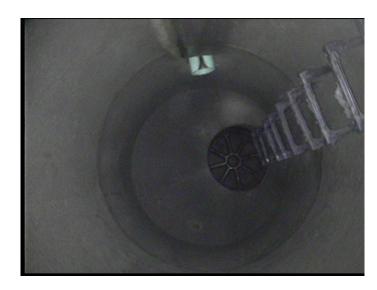
Code: AMH
Description: Manhole

Distance (ft): 249.7
Structural Grade: 0
O&M Grade: 0

Remarks: M-905-014
