Profile/Photo Observation Report

Customer: City of Hobart Clean Date: 10/13/2021 Shape: C

Street: North Michigan Avenue Flow Control: Not Controlled

US MH: M-704-014 DS MH: M-704-013 Total Length Surveyed (ft): 262.2

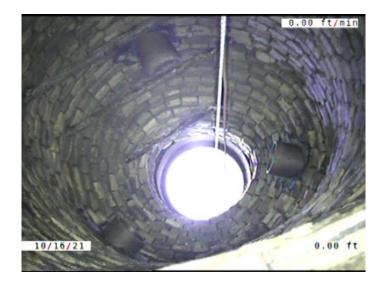
Code: AMH Description: Manhole

Distance (ft): .0 Structural Grade: 0 0 O&M Grade:

Remarks: M-704-014

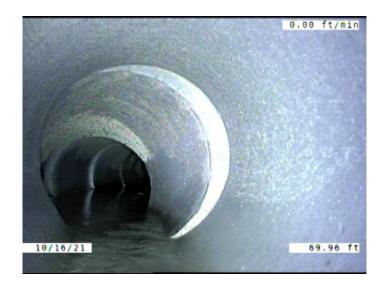
Code: MWLS

Description: Miscellaneous Water Level Sag

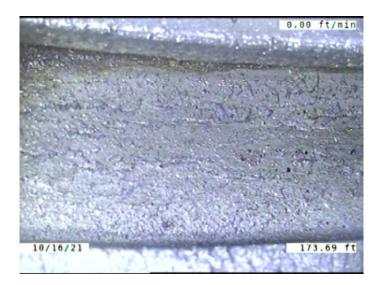
Code: JAL

Description: Joint Angular Large

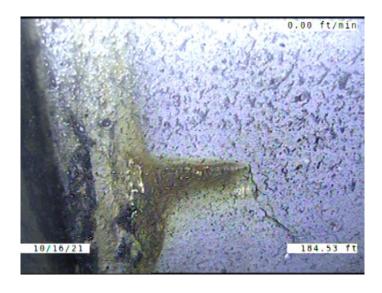
Code: ISB

Description: Infiltration Stain Barrel

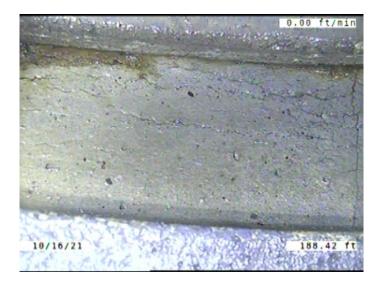
Code: JAL

Description: Joint Angular Large

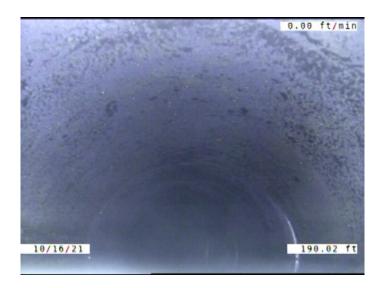
Code: MWLS

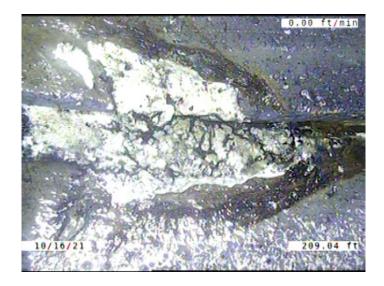
Code: DAE

Description: **Deposits Attached Encrustation**

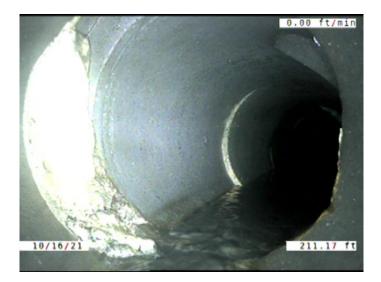
Code: LR

Description: Line Right

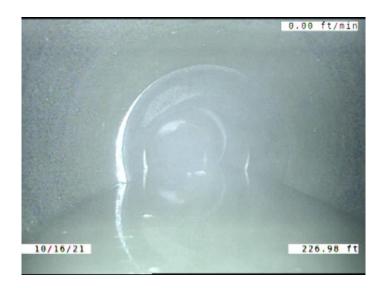
Code: DAE

Description: Deposits Attached Encrustation

Value Percent: 5.000
Continuous Index: F10
Within 8" of Joint: YES

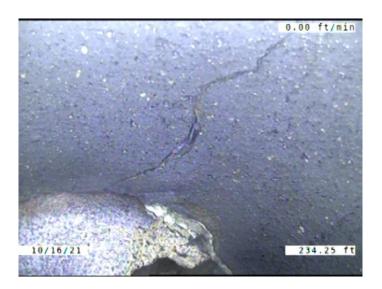
Code: FM

Description: Fracture Multiple

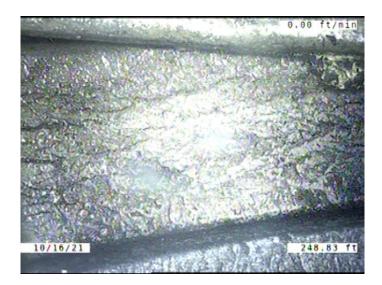
Code: JAL

Description: Joint Angular Large

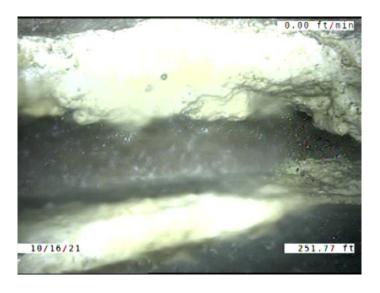
Code: DAE

Description: Deposits Attached Encrustation

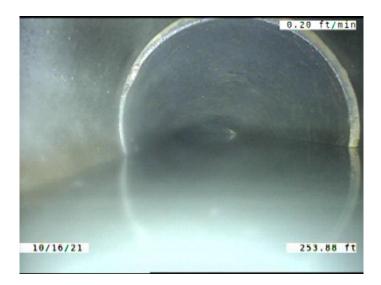
Code: MWLS

Description: Miscellaneous Water Level Sag

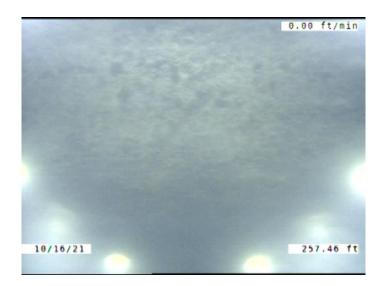
Code: MCU

Description: Miscellaneous Camera Underwater

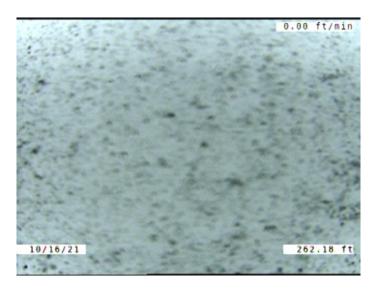
Code: MSA

Description: Miscellaneous Survey Abandoned
