## **Profile/Photo Observation Report**

Date: Weather: **PACP 7.0** 10/13/2021 Coding: Pipe Length (ft): 330.5 Owner: **City of Hobart** Pre Clean: **Heavy Cleaning** P.O.#: S. Bucklin PSR: P-704-018-017 YES502259 Surveyor:

Street: North Michigan Avenue Flow Control: Not Controlled

US MH: M-704-018 DS MH: M-704-017 Total Length Surveyed (ft): 330.5

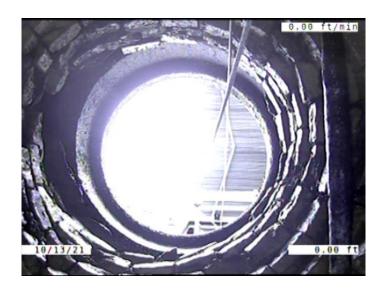
Remarks: M-704-018

Code: AMH
Description: Manhole

Distance (ft): .0
Structural Grade: 0
O&M Grade: 0

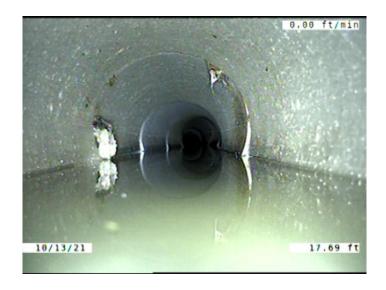
Code: **MWLS**

Description: **Miscellaneous Water Level Sag**

Distance (ft): 17.7 Structural Grade: 2 0 O&M Grade:

Value Percent: 15.000

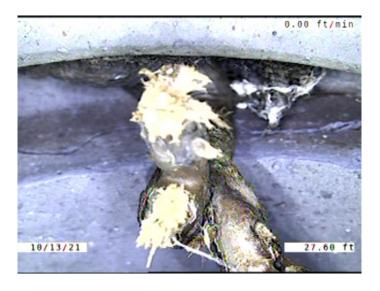
Code: RTJ

Description: Roots Tap Joint

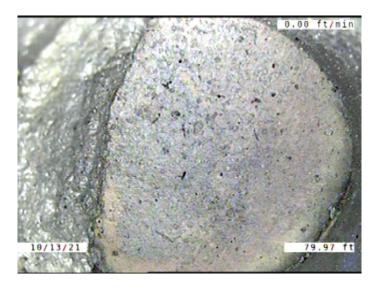
Code: TFC

Description: Tap Factory Capped

Remarks: CAP BROKEN

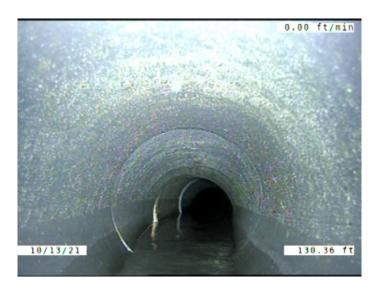
Code: MWLS

Description: Miscellaneous Water Level Sag

Value Percent: 15.000
Continuous Index: F02
Within 8" of Joint: NO

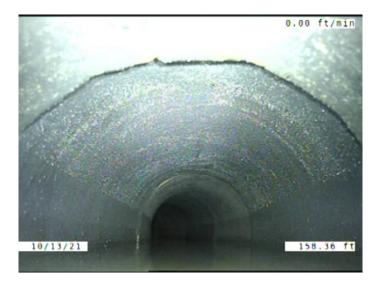
Code: MWLS

Description: Miscellaneous Water Level Sag

Value Percent: 15.000
Continuous Index: S03
Within 8" of Joint: NO

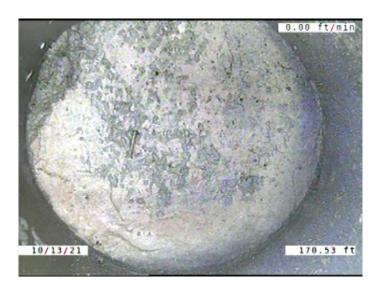
Code: **TFC**

Description: Tap Factory Capped

Remarks: RAGS AND TP

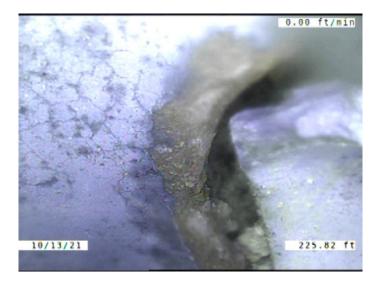
Code: SSS

Description: Surface Damage Surface Spalling

Distance (ft): 225.8

Structural Grade: 2

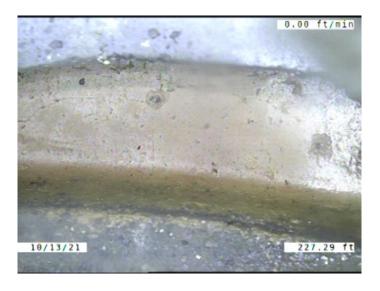
Code: JAM

Description: Joint Angular Medium

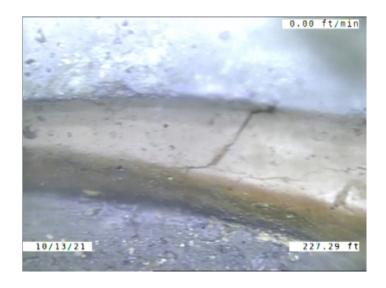
Code: FM

Description: Fracture Multiple

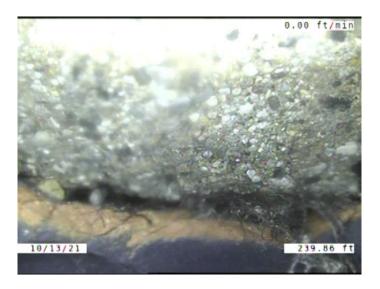
Code: RFB

Description: Roots Fine Barrel

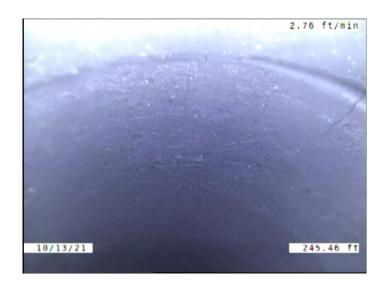
Code: **FM**

Description: Fracture Multiple

Continuous Index: **S04**Within 8" of Joint: **YES**

Remarks: Wandering

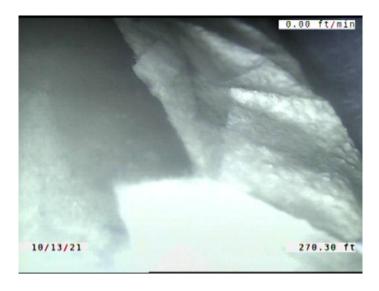
Code: DAR

Description: Deposits Attached Ragging

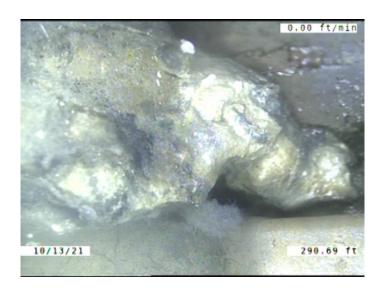
Code: DAE

Description: Deposits Attached Encrustation
